# BLUFFERS PARK, TORONTO

## Controlling overland storm water flow greatly improves beach water quality

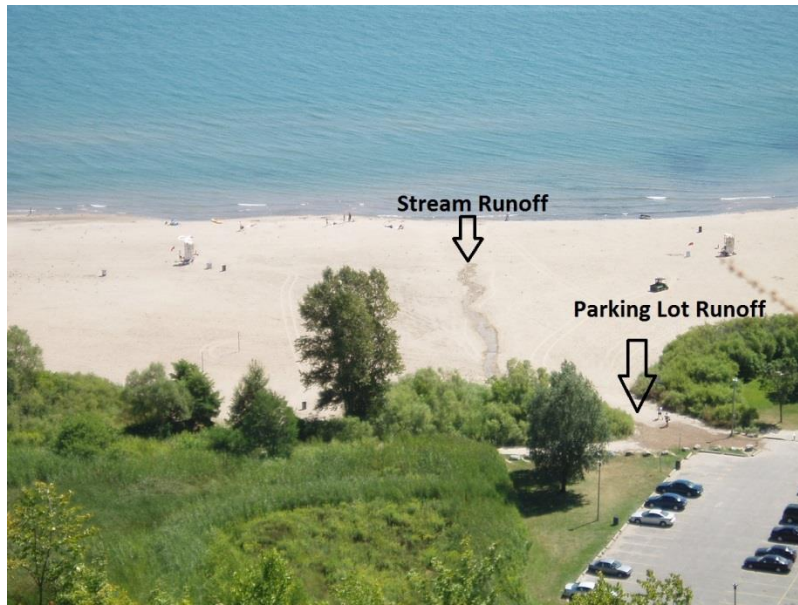
During the detailed site assessment it was noted that a small intermittent stream drained the marsh land north of the beach and discharged in the middle of the supervised swimming area. Contributing to this stream flow was run off from a nearby parking lot which was covered in bird droppings from the local waterfowl population. Testing of the stream and parking lot run off indicated high concentrations of *E. coli* in the sediment laden water. Microbial Source Tracking confirmed that high *E. coli* levels found in the stream water, parking lot run off and beach water were often not associated with a human or municipal wastewater source but were similar to known water fowl profiles. (T. Edge, personal communication, 2006).

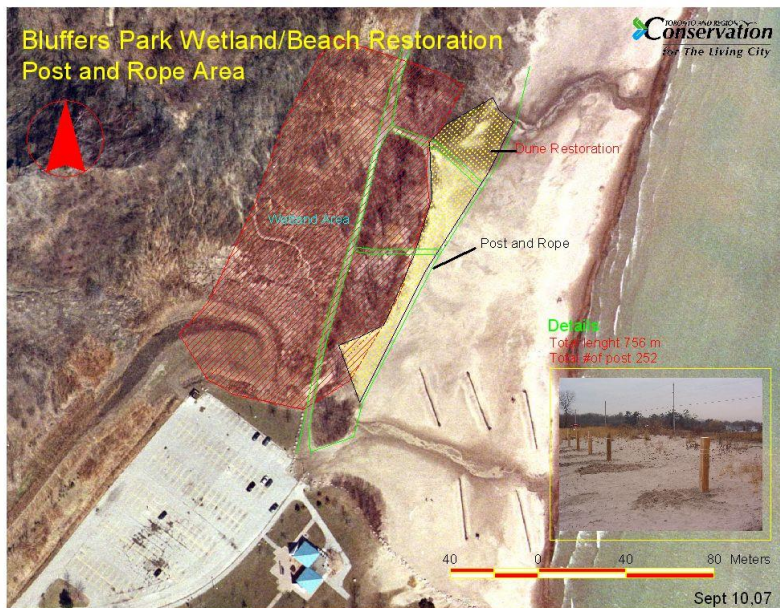
The solution? Toronto Water along with Toronto and Region Conservation Authority (TRCA) developed a plan that managed the storm flow in two phases. Firstly the marsh would be further bermed, allowing partial discharge to controlled infiltration ponds at the marsh edge. Secondly, any additional marsh flow would be redirected from its current western location to the eastern edge of the marsh, again allowing infiltration.

Construction took place in the early spring of 2008 to avoid disturbing park users. The design plan enhanced the natural setting of the park, improved beach water quality, provided a more diverse habitat for plant and animal species and add aesthetic value to the beach area. The results speak for themselves. Pre construction Toronto Public Health would post the beach with an advisory against swimming, often over 80% of the time.
